Conveyor and Source of Sediment

Hockely Branch is the tributary of Clements Creek

CLEMENTS CREEK CONFLUENCE
FLOODPLAIN RECONNECTION PROJECT
3RD FLOODPLAIN DISTRICT ANN ARUNDEL COUNTY

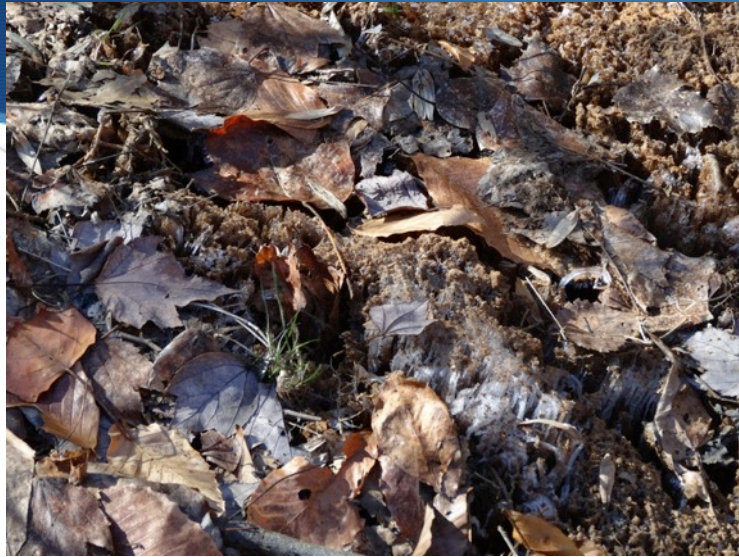
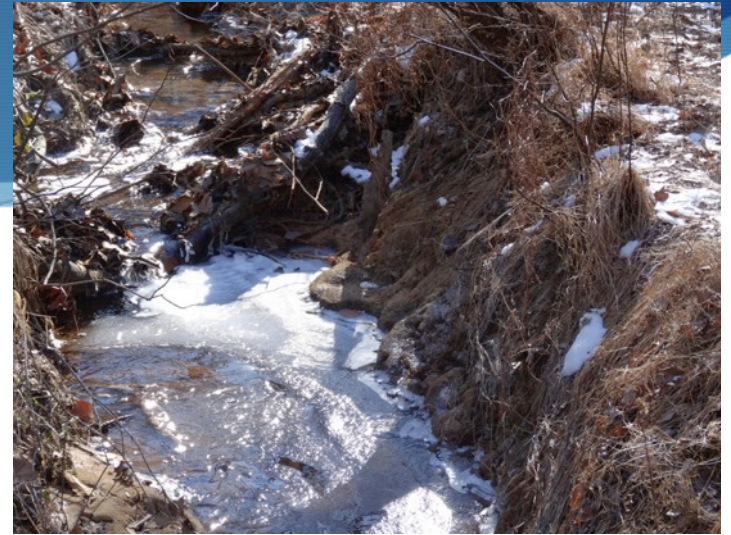
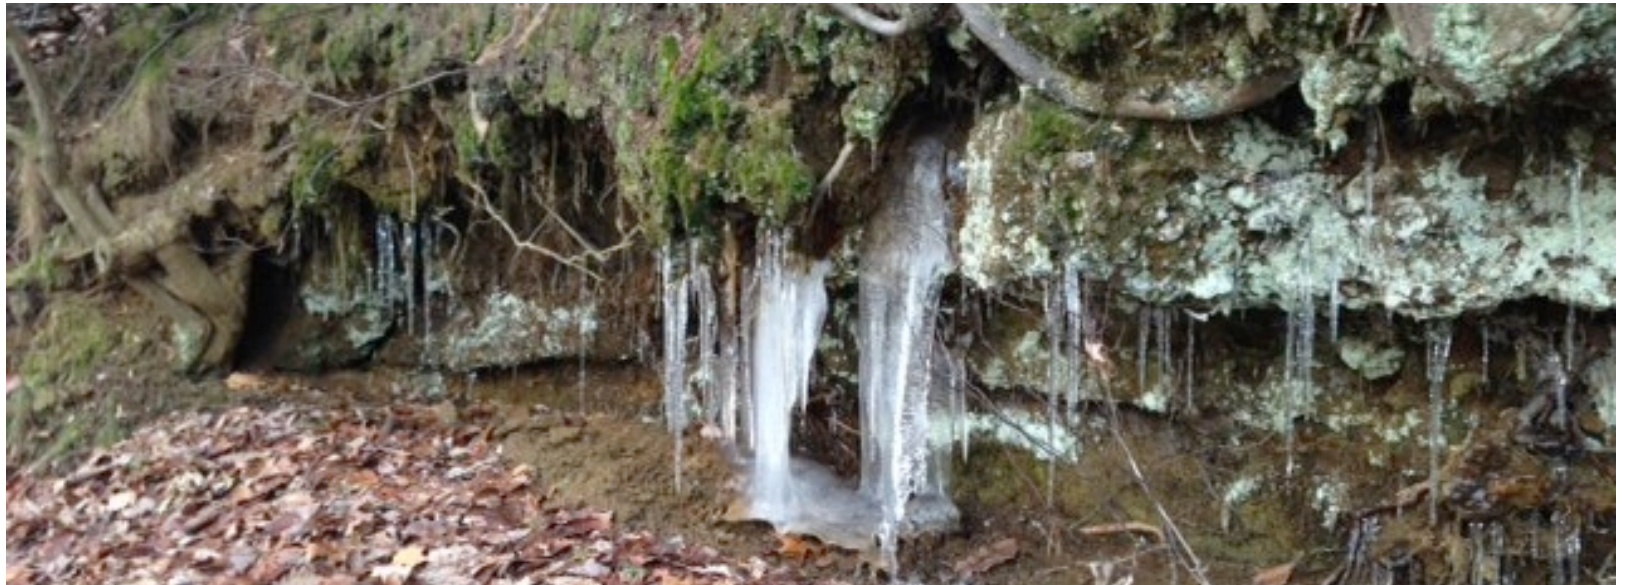
Freeze/Thaw cycle during the winter chisels off pieces of the incised banks

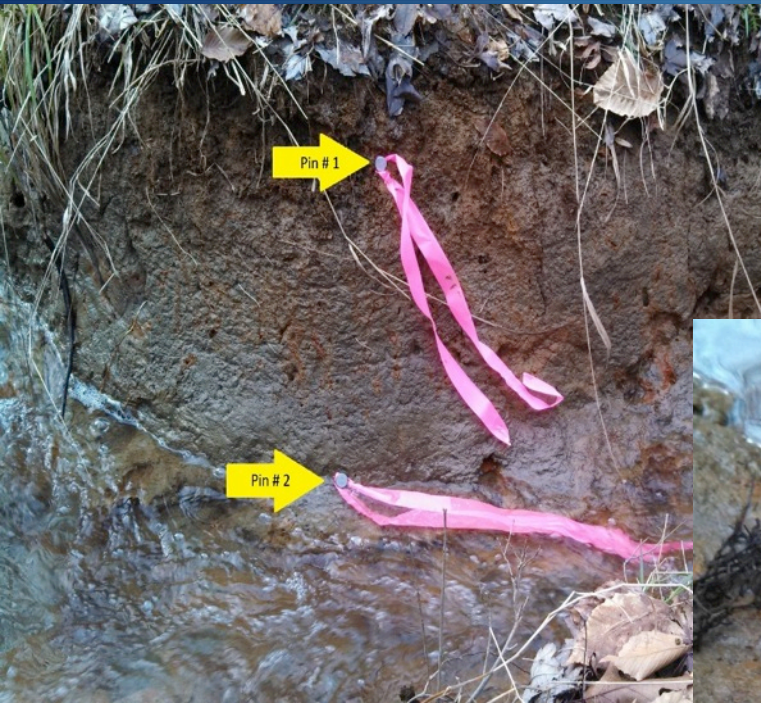
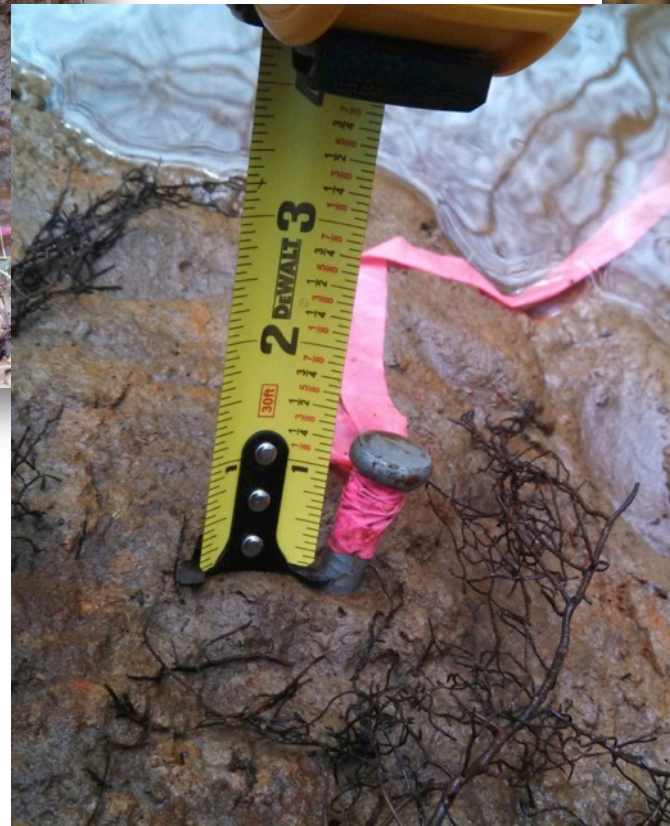
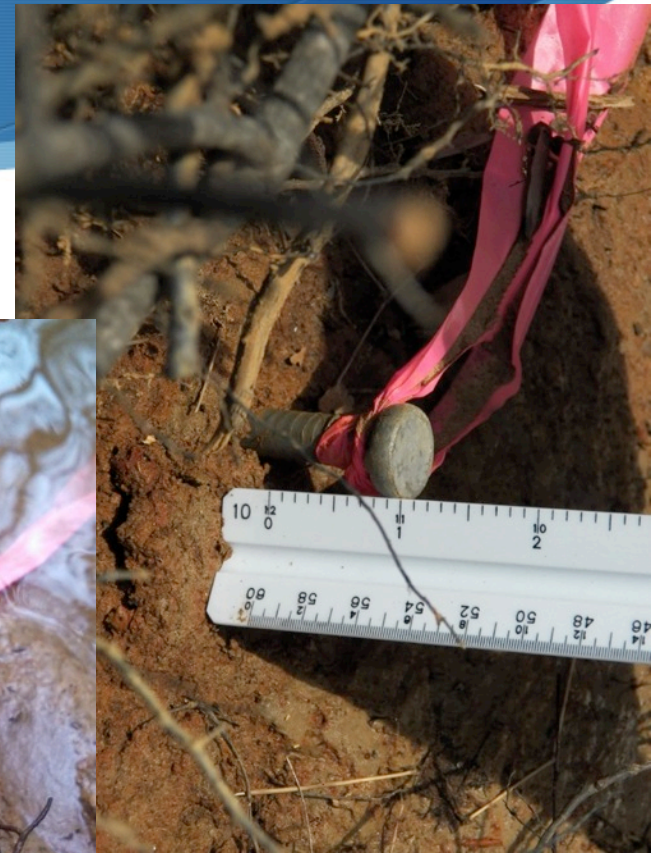
Bank Pins installed in Clements Creek in February 2014 show 1-1.5” of erosion by March/April 2014

Illustrates that the area downstream of the confluence is not only a sediment transporter, but also a sediment source

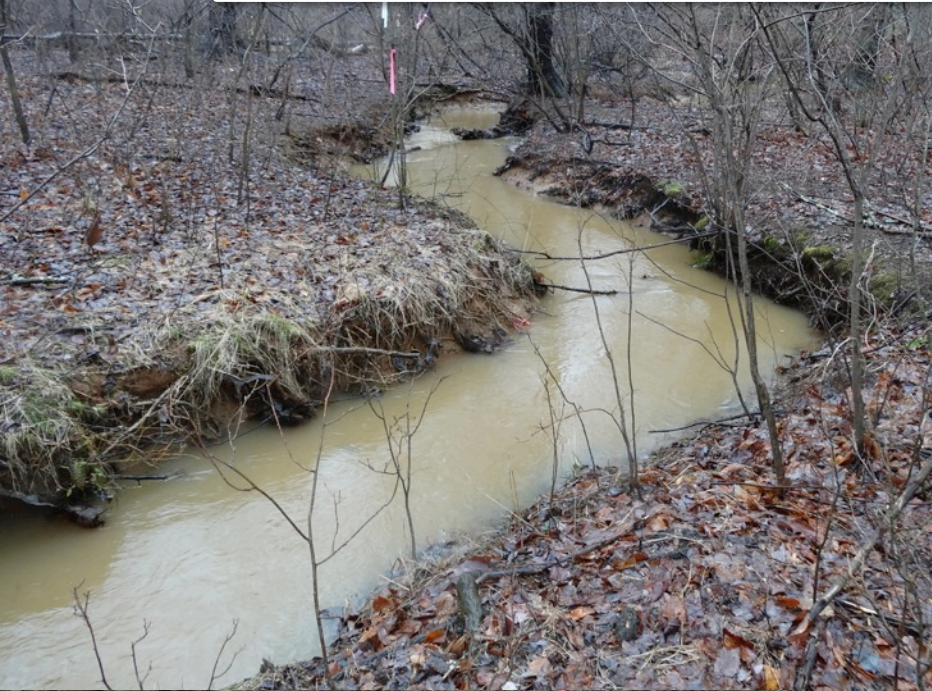
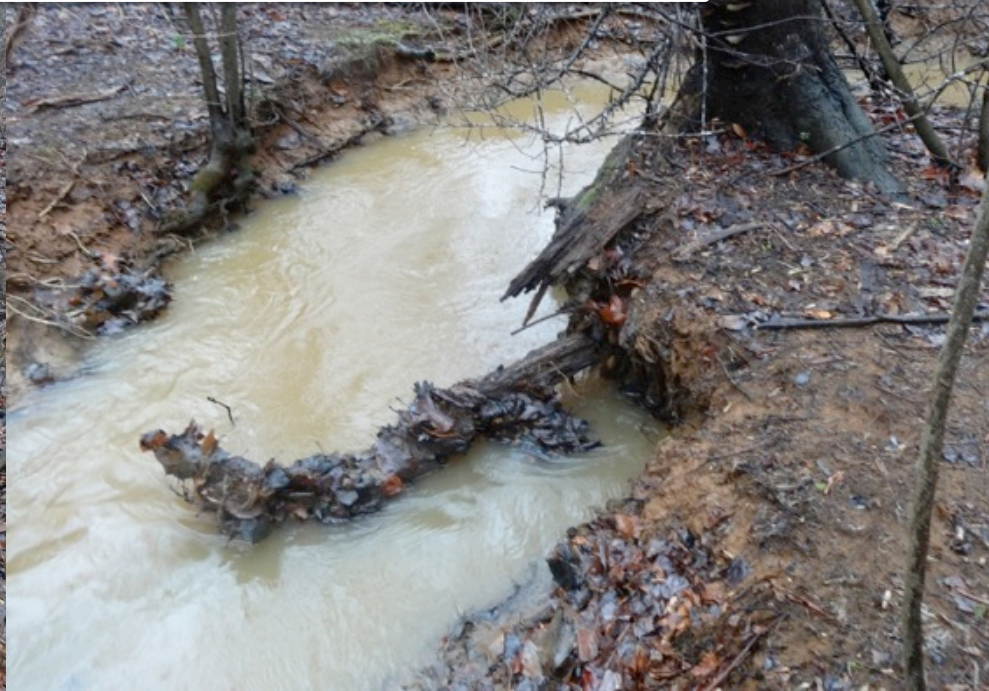
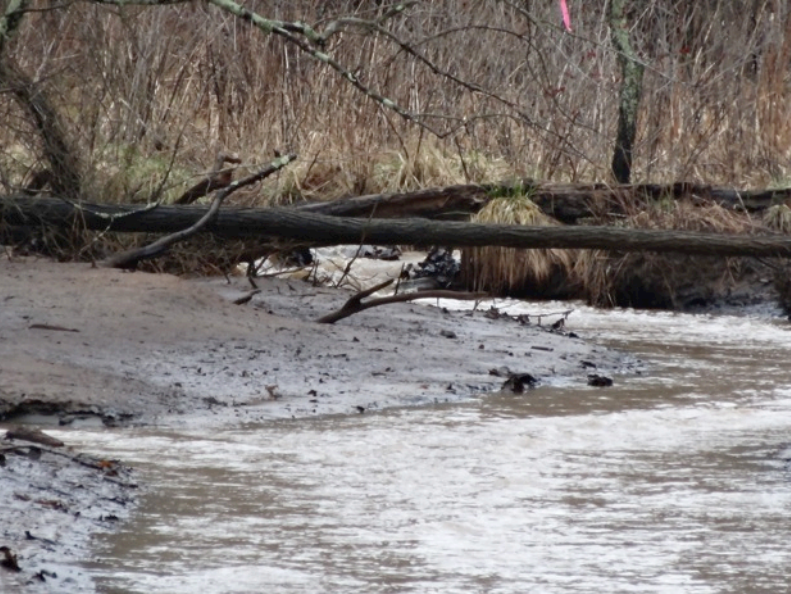
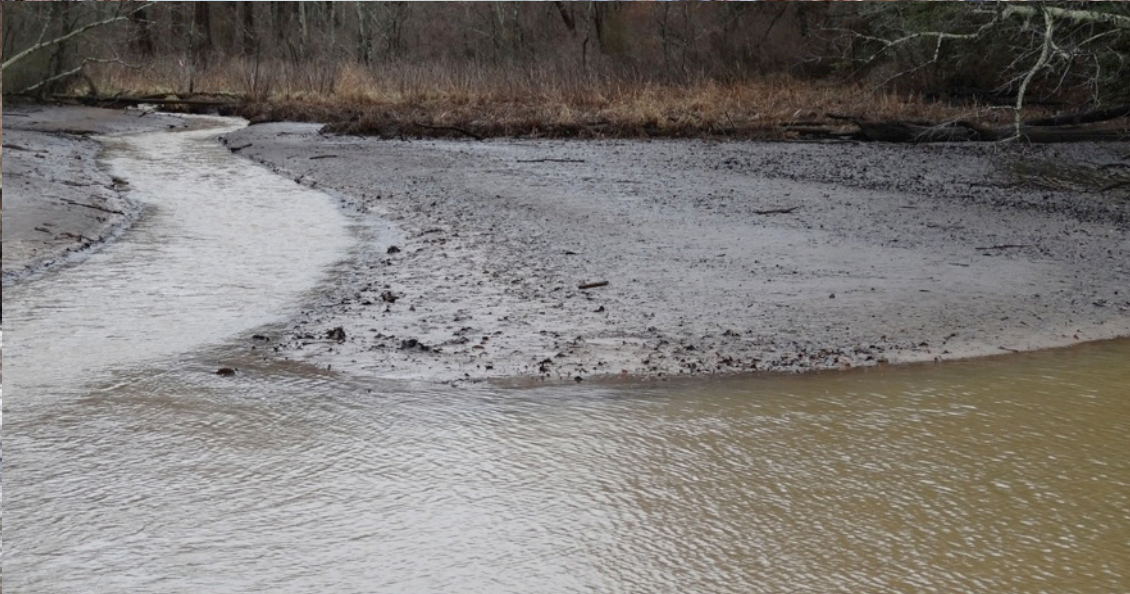
Spring and summer storms scour the banks, washing the freeze thaw debris downstream to be deposited downstream (March 30, 2014).

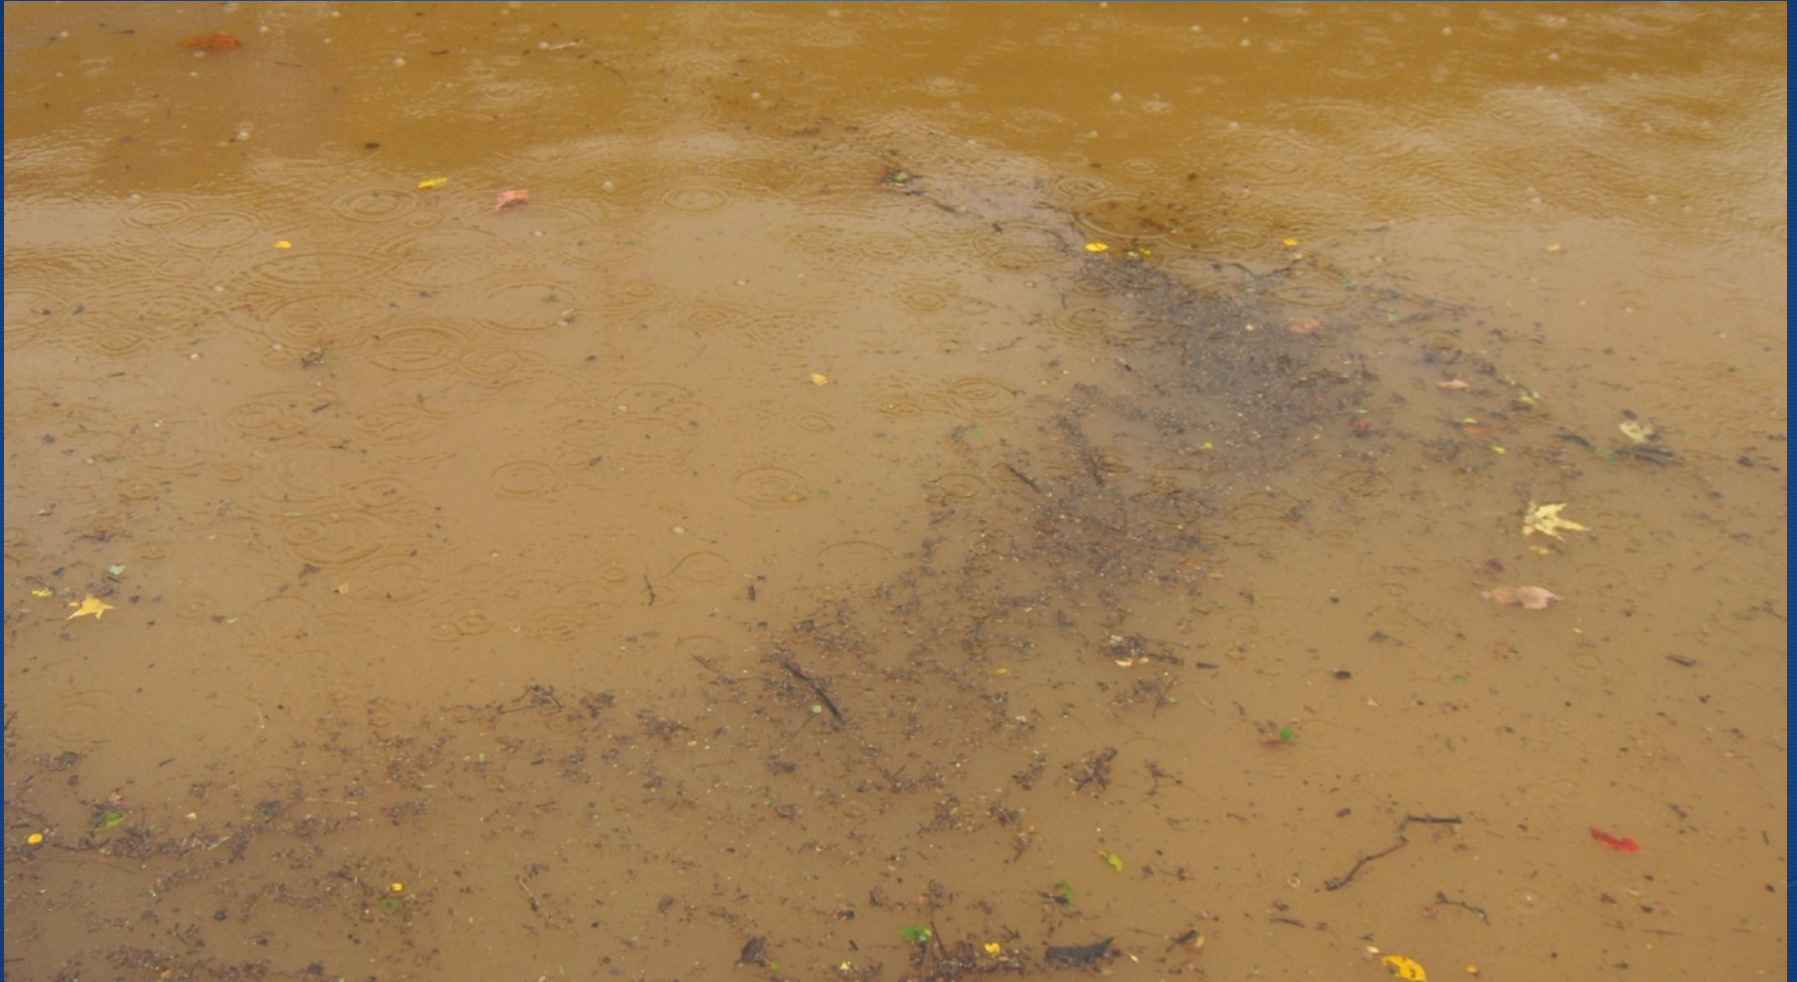
The sediment does not stop at the headwaters near the marina –the finer grains of sediment flow further out into the creek and mainstem of the Severn
